) **MOTION TO MODIFY RELEASE**
) **CONDITIONS**

March 23, 2016

Re: **Arizona v. Merritt**
DE Project Number: 16-1007
Project Report

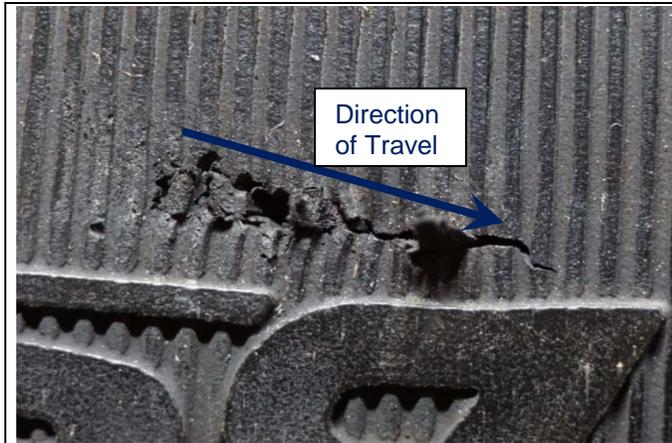
The tire had an external opening below the equator in the OSS sidewall at about the 8:30 clock position, as shown in Figure 1. The opening was circumferentially oriented. Distortion of the decorative lines on the sidewall were consistent with the penetrating object travelling from the 8:00 clock position toward the 9:00 clock position when entering the sidewall. This direction is also shown in Figure 1

Figure 1. Penetration of the OSS sidewall at about the 8:30 clock position.

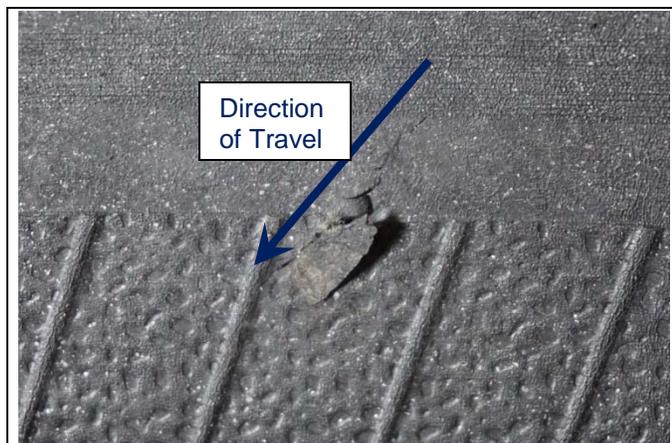
This opening connected to a corresponding opening on the inner surface of the sidewall. There was a gouge in the inner liner and inner body ply layer of the tire under the tread at about the 9:10 clock position, as shown in Figure 2. The gouge did not extend into the steel belts of the tread reinforcement, nor was there any corresponding exit opening in the tread area. The orientation of the gouge lined up with the penetration in the OSS sidewall, consistent with the two artifacts having been created by the same event.

Figure 2. Gouge in Inner Liner under tread at the 9:10 clock position.

The physical damage to the tire suggests that the bullet or bullet fragment (hereinafter "bullet") entered the OSS tire sidewall, penetrated the tire, and then struck the underside of the tire tread before stopping. The angle of the entry and the inner liner gouge, when taken together, indicate a trajectory where the bullet is traveling from the right side of the vehicle to the left and from the rear of the vehicle to the front. The bullet traveled under the vehicle in order to create the damage observed. Given that the exposed sidewall height on the tire (i.e., the height over the wheel flange) is about 3.4 inches, the bullet had to have had entered the tire in very close proximity to the contact patch (i.e., the point where the tire tread surface touches the road surface).

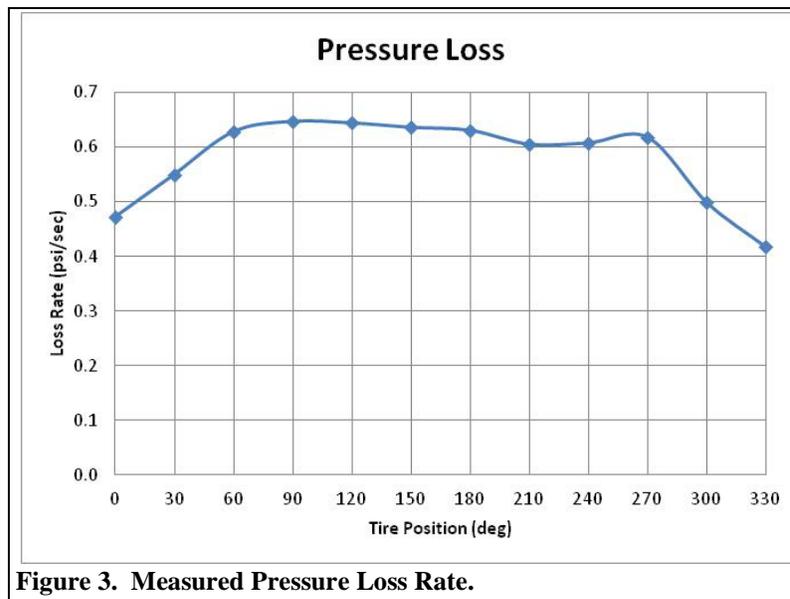
Position (Deg)	Leakdown Time (sec)
0	31.8
30	27.3
60	23.9
90	23.2
120	23.3
150	23.6
180	23.8
210	24.8
240	24.7
270	24.3
300	30.1
330	36.0

Figure 3 shows the pressure loss rate measured on the incident tire. Loss rate is simply the pressure drop (in this case, 15 psi) divided by the time for the pressure drop to occur. It can clearly be seen in Figure 3 that when the bullet entry point is located between the wheel and the ground, there is some reduction of the leak rate. This is due to the fact that, on a run-on-flat tire, the sidewall is in compression when it is carrying the vehicle load, and this compression tends to restrict the amount of air that can escape through an opening of the type shown in Figure 1. Note that there is no static orientation where the tire will not lose air pressure rapidly. In the case where the tire is rotating, the overall loss rate would be the average of the values shown in Figure 3, or about 0.58 psi/sec. This

indicates that the vehicle's TPMS would be able indicate low tire pressure within one second of bullet penetration of the tire sidewall. The actual response time would depend upon the sampling time of the TPMS installation as implemented by the vehicle manufacturer.
